Tylers  
Green  
Village  
Green

**Chepping Wycombe Parish Council Tracks Maintenance Policy**

**Core Geotechnics Limited**  
Richard Smy BSc (Hons) CGeol FGS

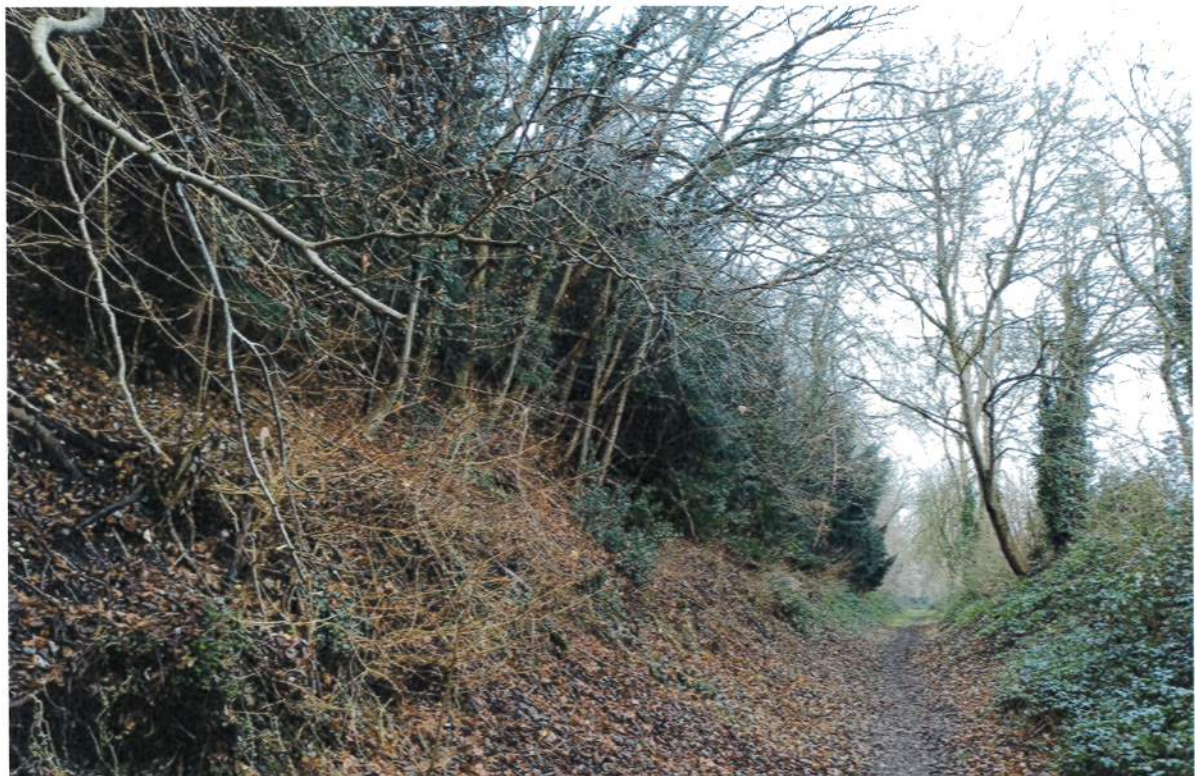
Photo 1 looking north-west from base of cutting with 15-20m high cutting face on left and circa 3m high face on right

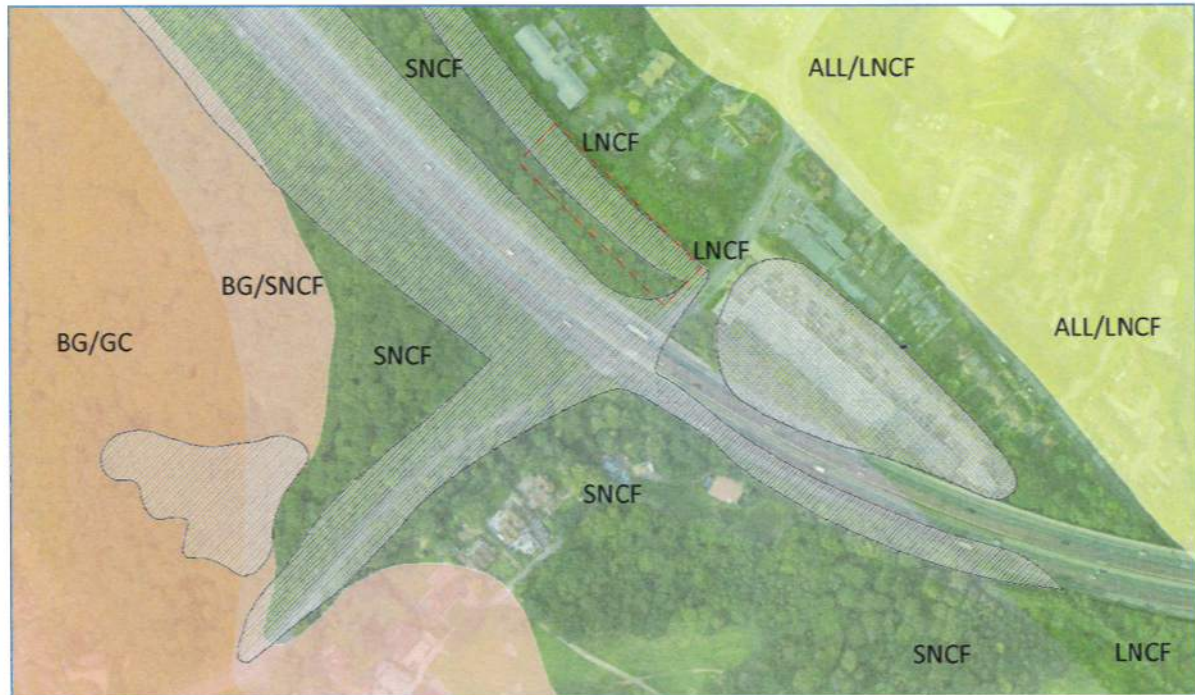
Figure 1 Geological Survey overlay showing approximate site boundary outlined in red

Areas of artificial ground (shown hatched on Figure 1) are identified and principally appear to relate to motorway construction although the cutting is also identified together with a relatively extensive area (location of former Loudwater railway station) to the south-east. A further area thought to be associated with a former gravel pit located some 250m to the south-west is also identified.

The presence of artificial ground appears to be in part in error as there was no evidence for the presence of made or filled ground within the cutting. Furthermore, apart from the approaches to the Toadsmoor Hill underpass, the M40 to the north-west appears to be carried in a shallow cutting (circa 1-3m) as the hillside rises to the south-west.

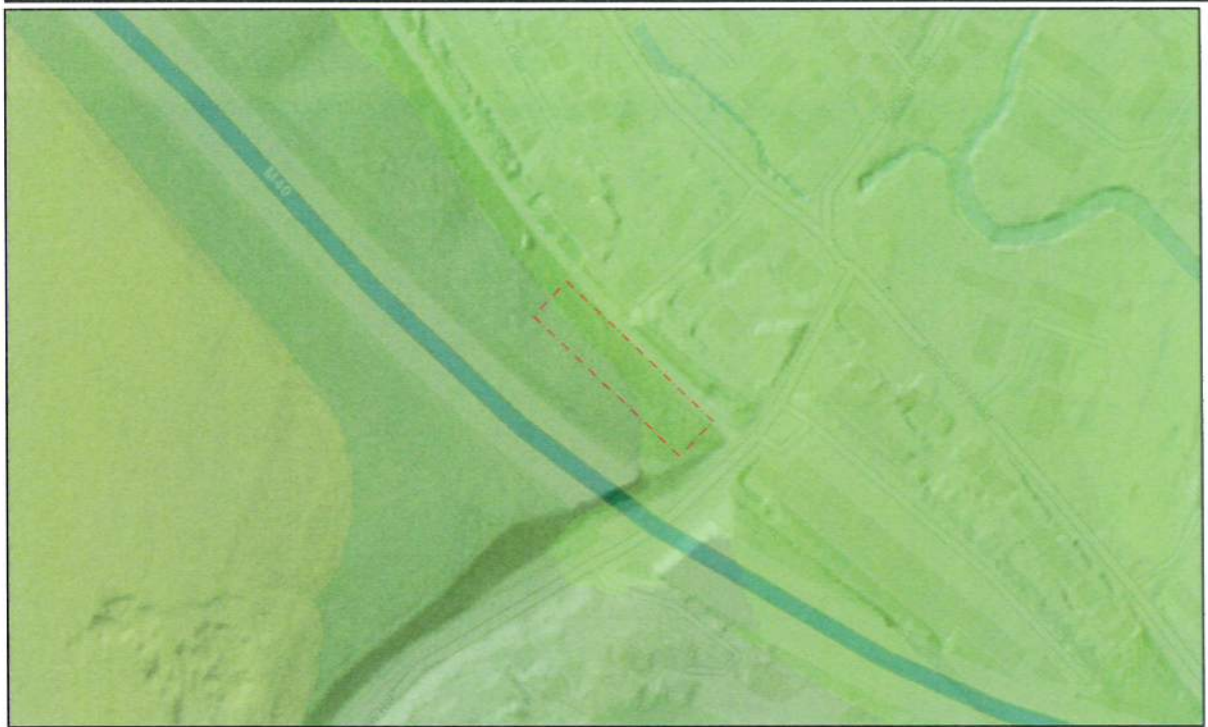
Plate 2 Lidar (1m DTM Model) with site outlined in red

The Lidar model shows an essentially even profile on the hillside forming the north-easterly facing cutting slope.

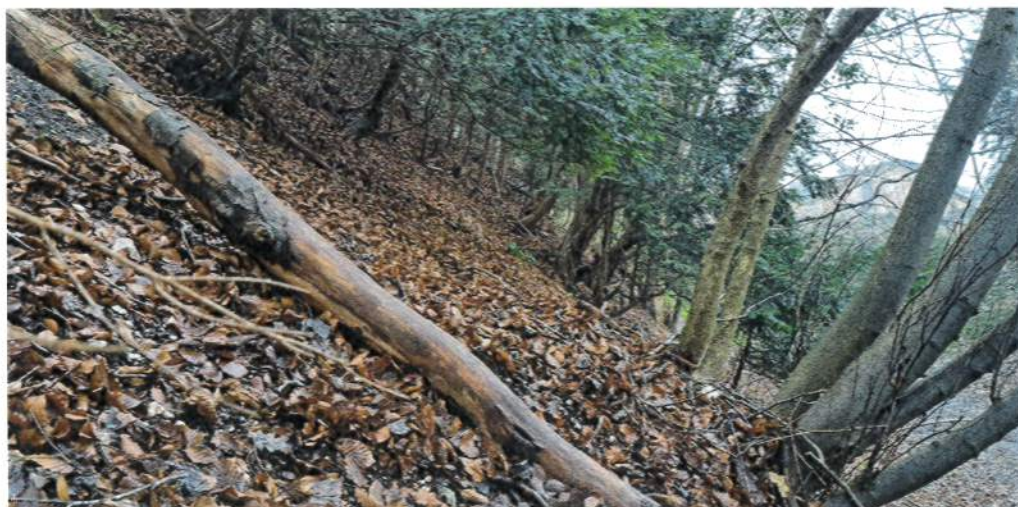
A walkover survey of the 15-20m high, north-easterly facing cutting slope was carried out on 11<sup>th</sup> January 2025. The survey was carried out by foot at the base of the cutting with a high level walkover at the crest. The cutting face was extensively vegetated with mixed deciduous trees and patches of undergrowth. The cutting face was generally fairly even in face profile with an overall slope gradient of around 35° (Photo 2).

Photo 2 General slope profile

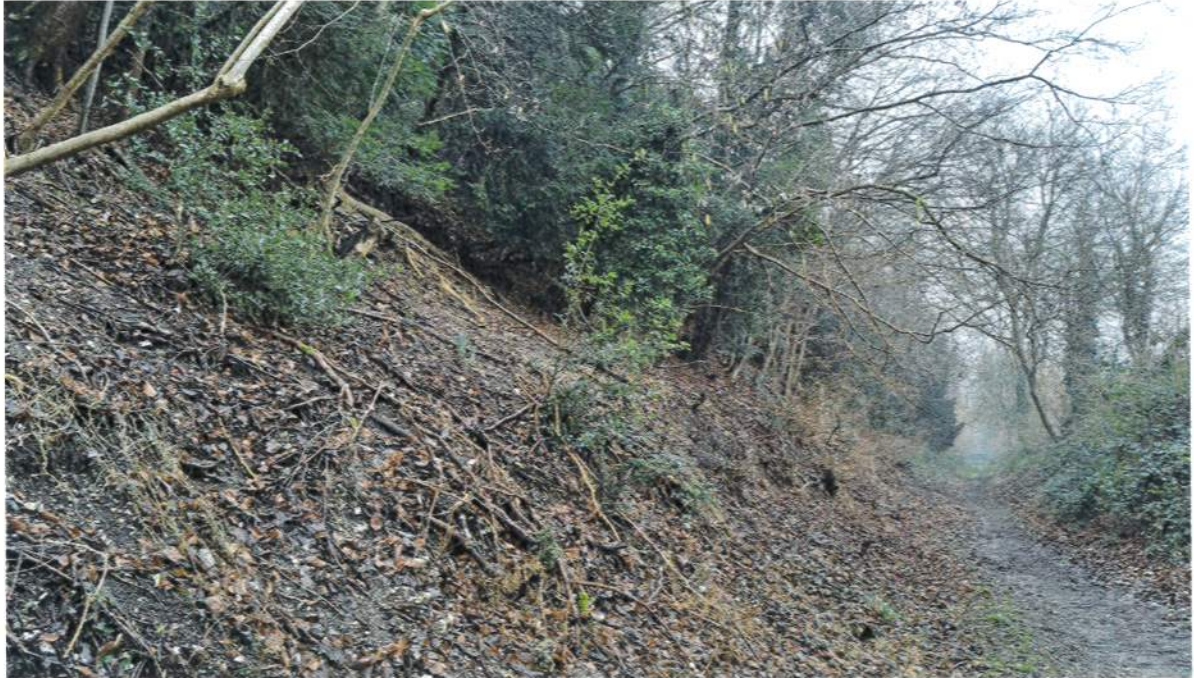
This was not universally the case however and localised areas of steepened slope which show accumulations of topsoil/subsoil at the lower levels of the face (Photo 3 & 4).

Photo 3 showing local accumulations of topsoil/subsoil on lower section of cutting face

Although the face of the slope was too steep to access on foot, in places, topsoil on the slope was observed to be thin or absent and in other locations was found to have accumulated toward the base of the slope as evidenced in Photos 3 & 4. Where thin or absent, it is thought that failed topsoil has historically been removed from the toe.

Given that the site comprises a wooded slope, remedial options to retain the remaining topsoil may be limited due to environmental factors, however more suitable planting (eg willow wands or dense shrub planting to help erosion and binding) may help stabilise the remaining topsoil. Given the nature of the site, hard engineering solutions are not likely to be economic or desirable.

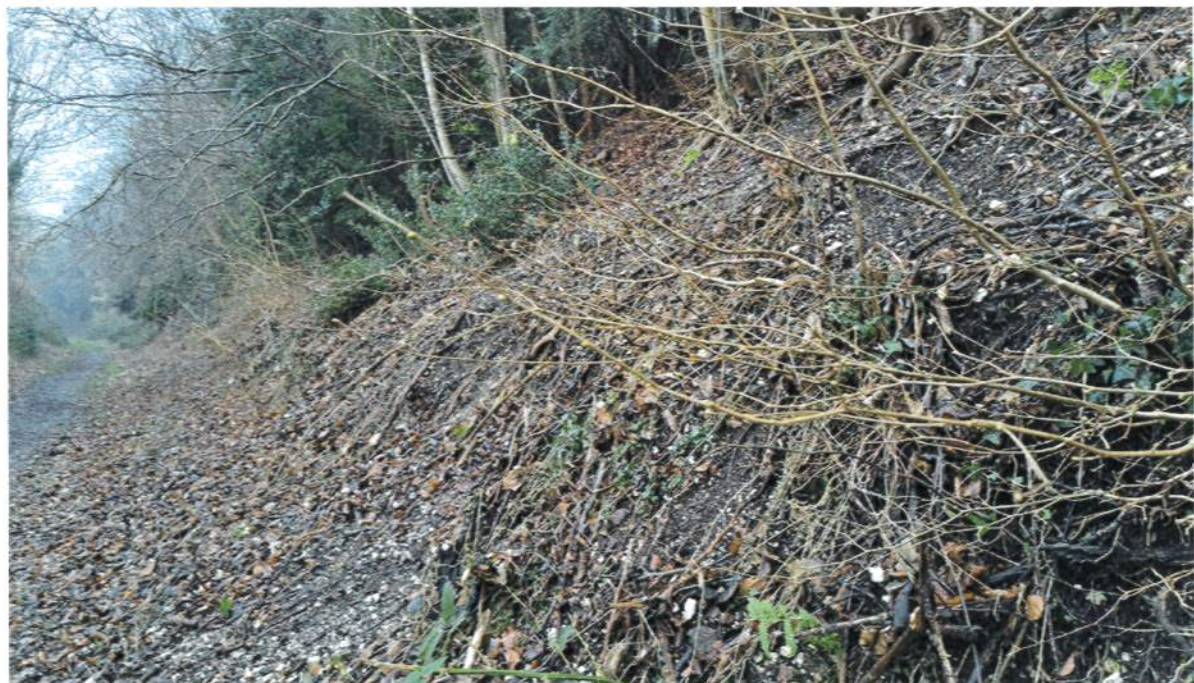
Photo 4 Oversteep topsoil/subsoil accumulation close to base of cutting

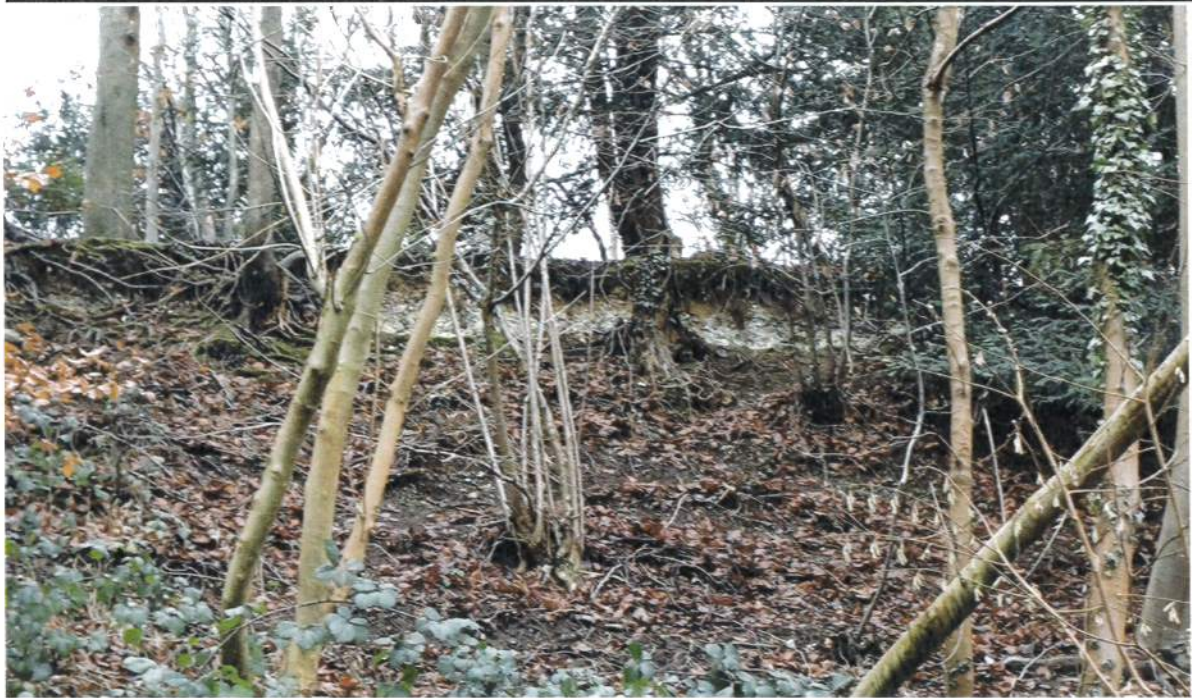
Of significance was the presence of a near vertical backscarp of around 0.5-1.0m high at the crest of the cutting face (Photo 5).

Photo 5 Near vertical backscarp at crest of cutting

Translational shallow failure at the interface between topsoil/subsoil and the underlying chalk is thought to have resulted in the near vertical backscarp at the crest representing where shallow failures have historically occurred. Translational failures typically occur as a sheet which results in an essentially planar face similar to that observed on site and as shown on the Lidar Survey.

The vertical backscarp at the crest is an issue and ideally this should be removed by rounding off the crest of the slope together with removal of potentially unstable trees located here.

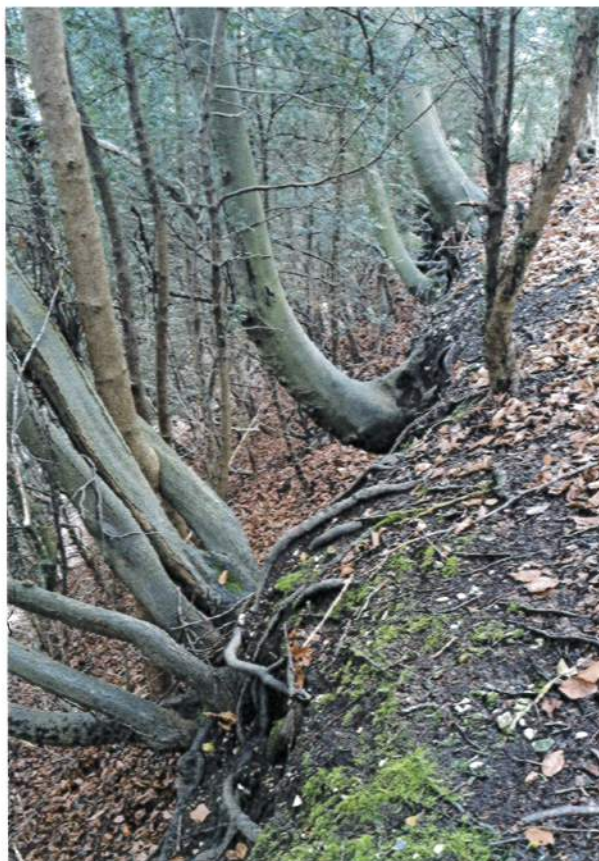
The near vertical backscarp showed approximately 0.30-0.50m of topsoil/subsoil over an off white chalk gravel which is considered to represent in-situ SNCF. The near vertical backscarp appeared relatively stable but to a large extent was held up by the rooting system of trees at the crest (Photo 6 & 7).

Photo 6 showing tree root systems partially stabilising backscarp at crest of cutting

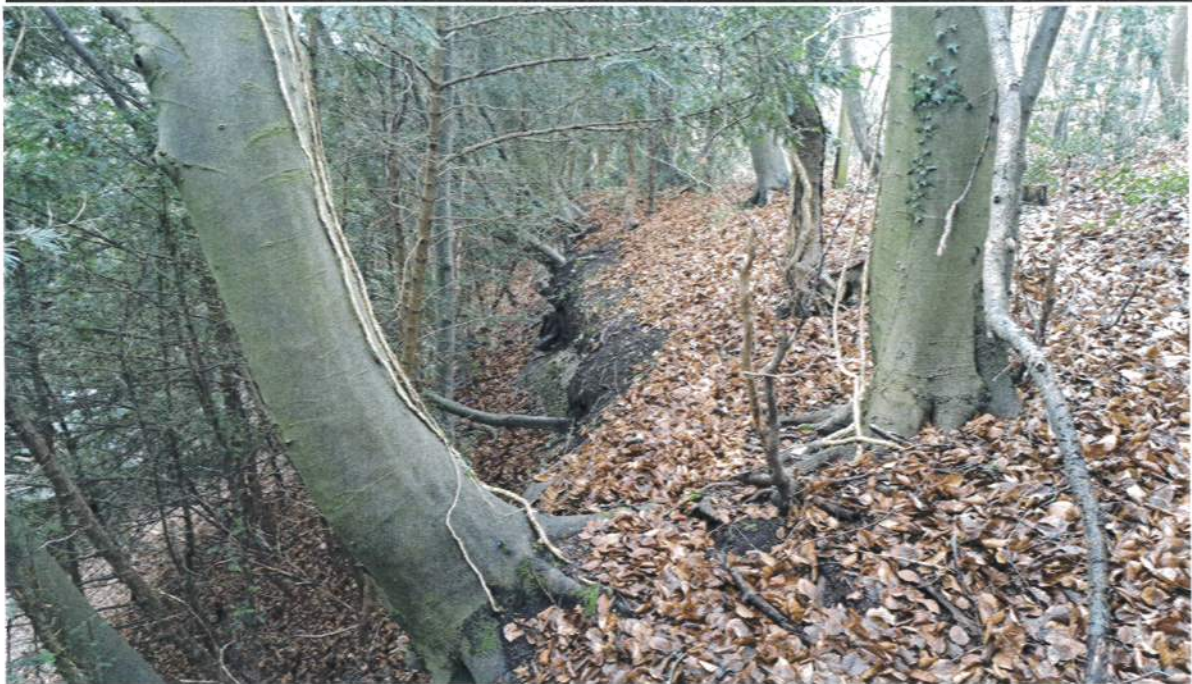
Photo 7 showing tree root systems partially stabilising backscarp at crest of cutting

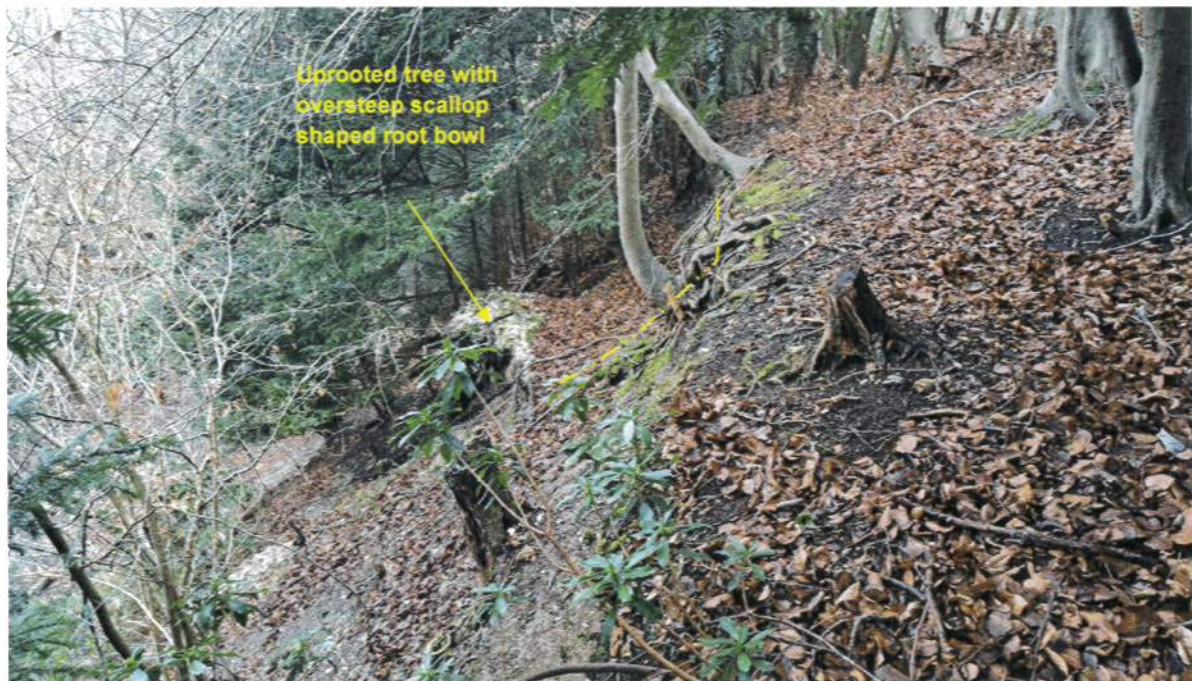
In places, there were trees located on the slope which appeared from cursory inspection to be unstable. There were also several fallen trees on the face which resulted in shallow overly steep dish shaped depressions in the face of the cutting where the tree root bowl has uprooted (Photo 8).

Photo 8 showing upturned tree root bowl

It is thought that the main issue relates to stability of the numerous trees located on the face and at the crest of the slope. Vegetation such as tree roots can have a binding effect but where very shallow rooted (often the case with chalk substrate), trees can have a destabilising effect resulting in toppling, scalloping and migration of the failure further upslope. Historic removal of the toe of failed topsoil would have a similar effect.

Given that a public footpath occupies the base of the cutting, there is principally a significant risk that toppling trees might cause harm to passers by and it is initially recommended that the advice of an arboriculturalist be sought with a view to identifying and removing or pollarding potentially unstable trees. Further geotechnical inspection is recommended following identification and removal.

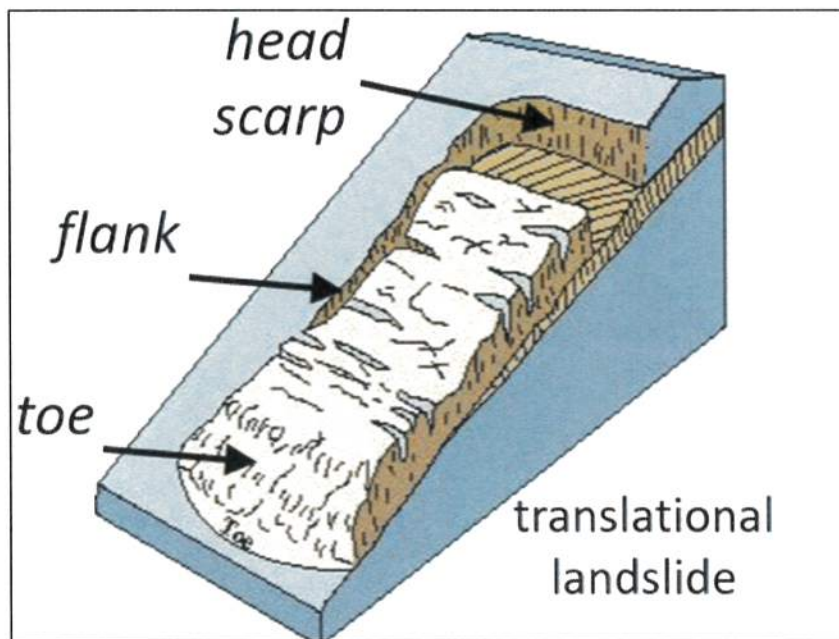
The cause of slope failure is considered to be multiple shallow translational slides of the topsoil/subsoil along the length of the cutting and which mantles the face of the slope as schematically illustrated in Figure 2.

Figure 2 Schematic showing generalised translational failure
