NOTES OF THE 22<sup>ND</sup> MEETING OF THE FLACKWELL HEATH RECREATION GROUND  
WORKING GROUP HELD AT CWPC AT 1330 ON 16<sup>TH</sup> JUNE 2022

The Play Inspection Company Ltd  
Unit 5 Glenmore Business Park  
Blackhill Road  
Poole  
Dorset  
BH16 6NL  
01202 590675

# Annual Report

## *Kings Wood*

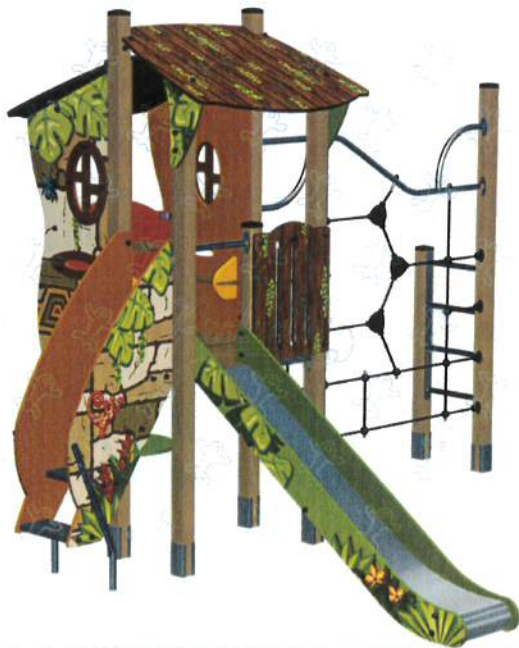
J3313-GA Area: 39.00 m2

The themed example below is from the Proludic Amazone options, one of six: Graphic, Medieval, ETNIK, Oceane and Metropolis. See: Grafic Games - Proludic UK

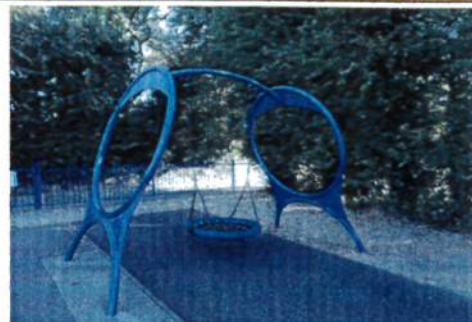
**Item:** Basket Swing - Type 1  
**Manufacturer:** Wicksteed Playgrounds  
**Surface Type:** Wet Pour  
**Item Quantity:** 1  
**Equipment Compliance:** No  
**Surface Area Compliance:** No

There are gaps opening between the surfacing and the edging surround or between the joints in the surfacing - Monitor for any further deterioration and repair as required

The surfacing dimensions are short and do not meet with the requirements of the current applicable standard - Monitor - no remedial action recommended

The seat clearance from finished surface level to the underside of the seat is too low and does not meet the requirements of BS EN 1176 Part 2 (400mm minimum clearance required from rigid part of seat in most onerous position) - Adjust seat clearance

The chain openings are in excess of the 8.6mm as recommended by BS EN 1176 - Monitor - No remedial work recommended

The chain links are worn in excess of 40% and require renewing - Replace worn chains

There is some wear to the shackles. - Monitor for any further deterioration and replace when 40% worn

The bushes are worn or missing - Replace worn or missing bushes

The surface is worn or damaged - Repair the bitumen to provide a uniform surface

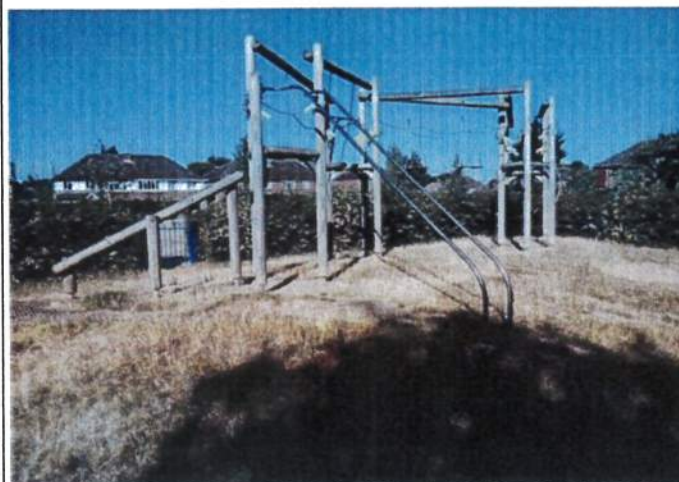
### ! 12 - Moderate Risk (Finding 10)

**Item:** Activity Equipment - Climbing Frame  
**Manufacturer:** Eibe Play Ltd

**Finding:** There is or are fixings missing on the stepping post **Action:** Replace all missing fixings allowing it to move along the bar

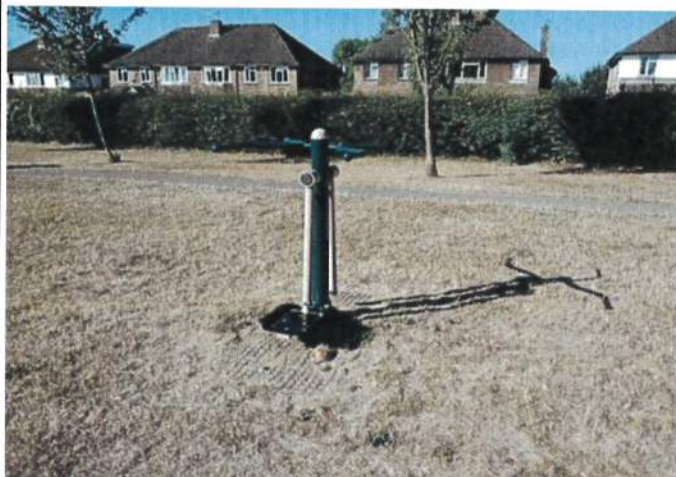
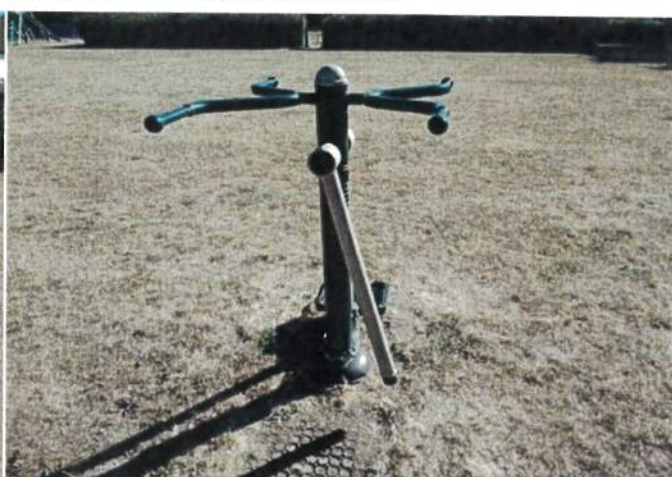
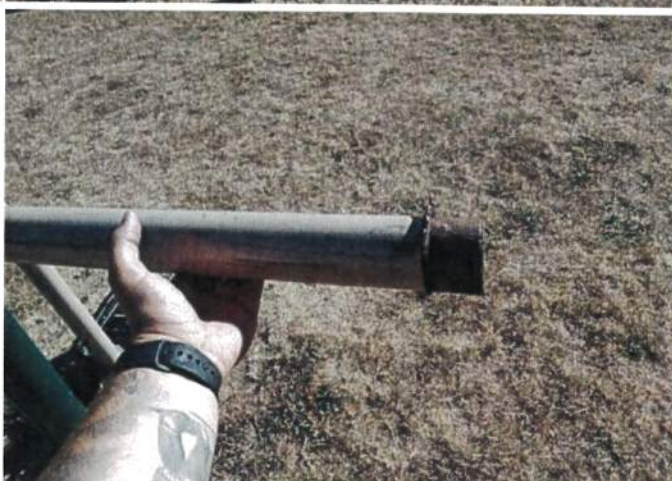
**! 16 - High Risk (Finding 1)**

**Item:** Outdoor Fitness Equipment - Air Skier  
**Manufacturer:** Outdoor Fitness Centre

**Finding:** The item has been severely damaged exposing sharp edges that swing freely. Office contacted to inform client

**Action:** Repair or replace the item.

THIS PIECE OF EQUIPMENT HAS BEEN REMOVED  
UNTIL THE NEW SECTION CAN BE FITTED

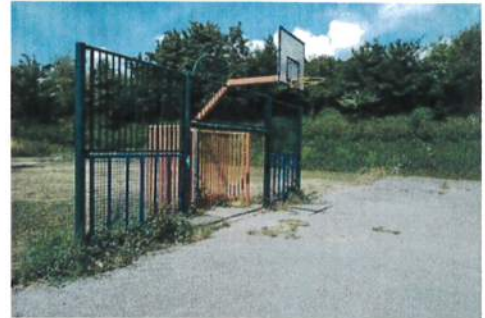
Item: Multi Use Games Area (MUGA)  
Manufacturer: Wicksteed Playgrounds  
Surface Type: Tarmac  
Item Quantity: 1  
Equipment Compliance: No  
Surface Area Compliance: N/A

There is weed / vegetation growth on, between, or around the edges of the surfacing - Remove weed / vegetation growth

There is moderate damage to the surface - Repair the damaged areas of surfacing

There is some graffiti present - Remove the graffiti

There are redundant projecting brackets - Remove

There are post / end caps missing from the item - Replace missing post caps

A number of fixing(s) have worked loose - Secure all loose fixings

There are trip hazards at the edges of the surface - Reinstate surrounding surface levels to remove the trip points

The surface has eroded and the foundations are exposed creating trip points - Reinstate surrounding surfaces to cover the foundations

The mesh panels are damaged - Repair

There is/are finger entrapments in the framework and the item fails to meet the requirements of BS EN 15312 Clause 4.4.2.2 Entrapment of fingers - Monitor - No remedial work recommended

The weld(s) on this item have failed - Repair item

A clearly visible facility sign should be provided in a prominent position with the wording as detailed BS EN 15312- the equipment is not intended for children less than 3 years old- the warning - Do not climb on the framework or nets- the warning - Do not hang on the ring (if provided)- the warning - Do not wear rings or other jewellery- name and telephone number of the administrator- number to call in case of accident - Provide signage to BS EN 15312

There are projecting wires on the framework - Remove

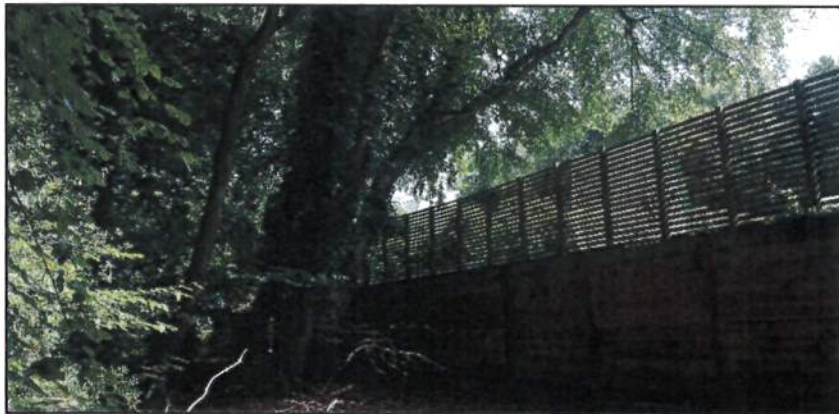
Safety inspections were undertaken by Graeme Christie. Recommended tree safety works along the northern boundary adjacent to residential properties were reviewed and deemed sensible, including removal of five mature beech and seven trees requiring minor works and removal of ivy to improve future inspections. Larger dying and dead trees adjacent to paths are recommended to have upper canopy removed and stems left as monoliths for deadwood habitat, providing the stem is stable and upright and away from permanent dwellings.

**Leaning beech trees highlighted for removal in the safety inspection**

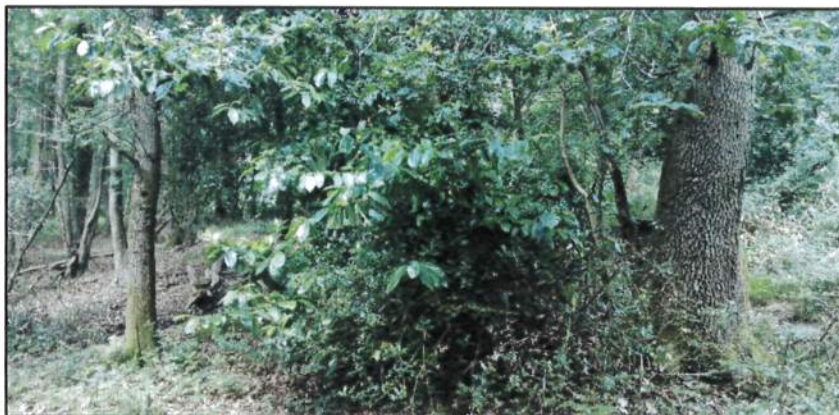
Isolated instances of laurel have been noted in the woodland, which is potentially invasive and recommended to be removed, including removal of roots or treatment with an appropriate herbicide to prevent regrowth.

**Laurel growing in amongst a holly shrub**

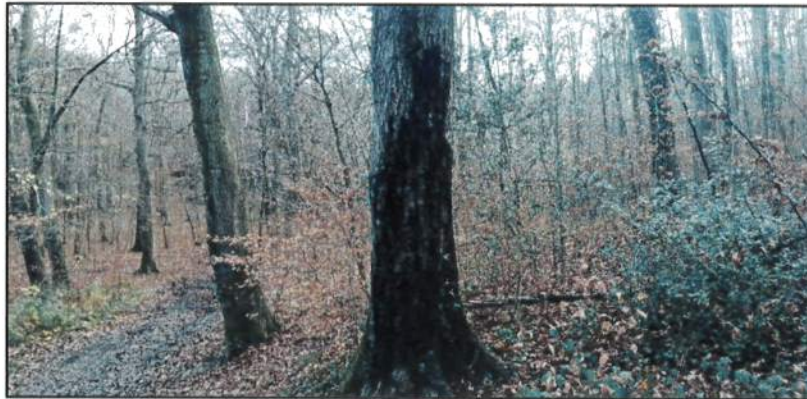
Public safety is a primary objective in Kings Wood, and regular inspections and necessary remedial works are essential. Windblown trees over paths are a frequent event in Kings Wood and can be reduced through regular interventions. Inspections during summer can reveal instances of crown dieback, whereas autumn and winter are better for identifying wood decay fungi. Stem bleeding is often a sign of internal rot and loss of stability.

**Stem bleeding on a beech tree**

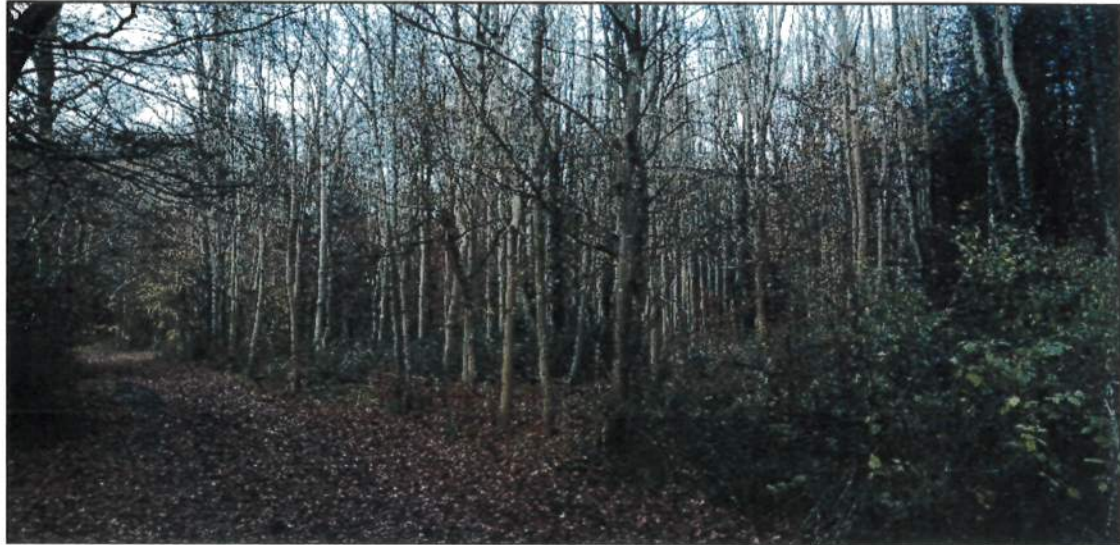
**Small stand of young ash by the public bridleway**
